Pimp My Blower Door Kit

The Blower Door Makeover

BY GREG LABBÉ

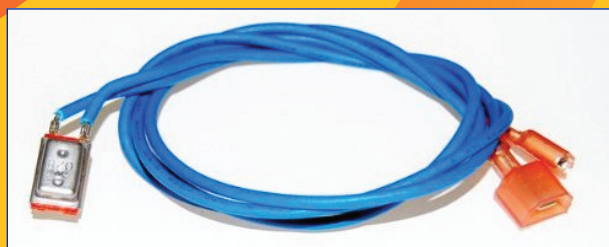
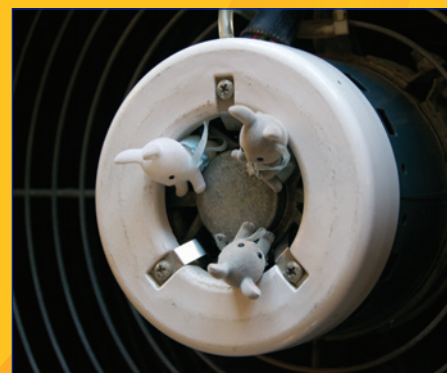
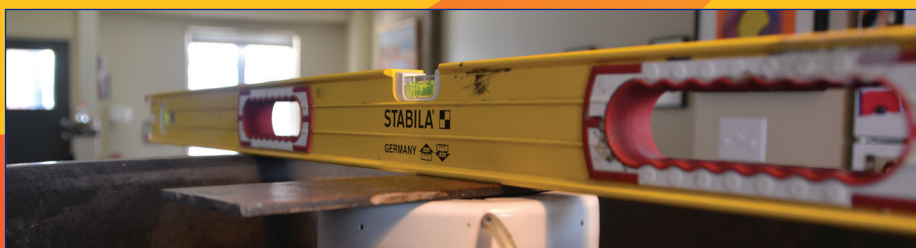
(top left) Out with the old thermal cut off. (top middle) Replacement thermal cut off. (top right) Pulling dust rabbits out of motor inlet. (left) Spacer between edge and sensor.

The Energy Conservatory's Minneapolis Blower Door uses a superb workhorse of a motor, made by GE, to move 30 minutes of air a day. It's as if they put the engine of a BMW M3 into a 16-foot fishing boat built to last a few generations—as you'd expect from something that's made in America. I knew the motor must have a malfunctioning thermal cutoff, so I spoke to a chap at the manufacturer and asked if he could source a new one for me. "No" was the short but polite answer. "You'd have to buy a new motor." This was not an option, because the motor is worth over a third of the machine's value new. My next-best option was to take it to my dad—Bob's an old-time electrician whose best friend spent his life rewinding and repairing all manner of electrical motors. He called me up the next day to give me the diagnosis. "I found and replaced the high-temp sensor today," he says in his best French Canadian accent. "I cleaned out the motor—an exceptionally well-made motor; there was no sign, visible or in smell, of heat stress." The replacement part cost \$30 online at Amazon. Regarding the motor, if you ever do a job like this yourself, you should clean it and pull out all the dust bunnies from the intake face (see top right photos).

While the grille was off, I took the time to position the sensor hub by placing a flat $\frac{3}{16}$ -inch spacer on a flat table for the Model 3 fan (see bottom photo above). I placed the whole fan on the table, centering the flow sensor hub on my spacer. Then I loosened the bolt holding the motor to the fan and ensured that both the flow sensor and the black fan housing were sitting flat on the spacer and table respectively. Then I retightened the clamp holding the motor. I flipped it over and checked the alignment with a 4-foot level. Another good deed done. A note of caution: Never detach the clear hose from the flow sensor. Speaking from experience, the hose comes off easily, but the force of pressing it back onto the glued nipple can easily push the nipple into the flow sensor, permanently ruining the sensor.

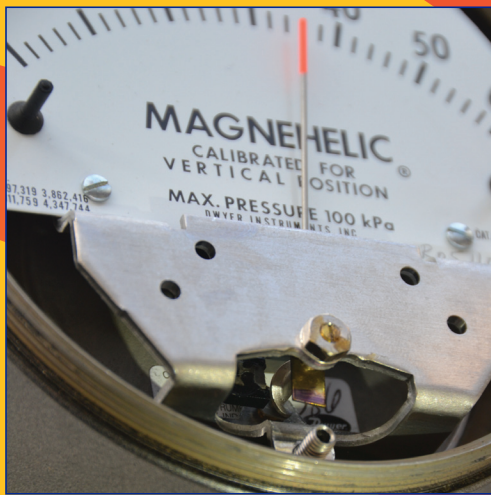
Close up of Magnehelic.

There are no batteries in the robust and simple Mangnehelic gauges, and yet the Energy Conservatory discontinued them several years back and replaced them with a more compact and flexible gauge. Dwyer Magnehelic gauges are an engineering feat, and I salute the genius who devised this über simple and purely elegant device. If you've ever wondered why they call them "Magnehelic," take them apart and have a look! The axle of the indicator needle is encircled by a helical iron fin, and the diaphragm—which moves up and down in the axis of the indicator needle—has a powerful magnet attached to it (see top photo next page). This magnet is very closely positioned next to the helix, and as the diaphragm moves up and down, it pulls the helix along, which makes the indicator needle turn. You can buy replacement gauges for less than \$140.

Though the Dwyer gauge is very robust in design, its one weakness—aside from the fact that it needs to be level—is that the zeroing adjustment screw seizes up. Not sure if this is so, but perhaps the rubber seal dries over time as it connects internally to a hex head stainless steel setscrew inside the case. If you do

take the gauge apart, be gentle when you reassemble it, since the setscrew on the crystal needs to mate with the hex head of the setscrew inside the case. Note too that you should be superclean when you work on the gauges. The bezel should be tightened to the point where the case is airtight.

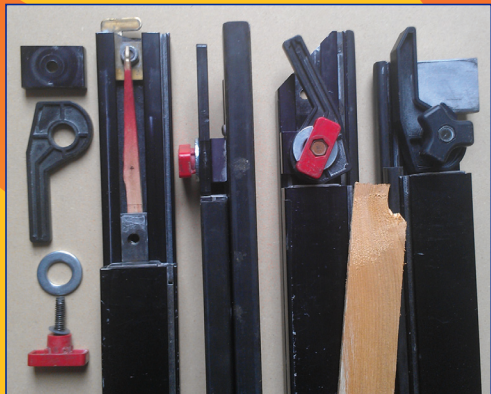
Inserting 14mm washer in cam.

The extruded-aluminum door frame of my Model 3 was frail, and it rattled when I assembled it. When I cammed it in place to do a test on a house, it withstood no more than 30 Pa of house pressure before suddenly popping out of the door. I discovered that the vintage cams were not camming as well as they once did. There were two reasons: The old cams were made of a thinner, more-rounded stock than the new cams, which have a wider face, and the red screw handles used to lock the sliding block in place had four thin plastic postings around the stem that were worn. This allowed a lot of play in the camming lever.

I easily fixed this last problem by carefully unscrewing the bolts out of the sliding block—the screw threads were crimped on the end to prevent them from being unscrewed—then placing a 14-mm washer between the outside face of the cam and the red handle (see second from top photo on previous page). Installing this large washer made the whole door assembly significantly less floppy when I carry the assembled door frame between new houses for sequential testing. This was a simple 30¢ fix as opposed to the more-expensive and involved fixes that I had in mind, which were to build up the face with epoxy, or build a new cam out of a solid piece of wood or plastic. A note of caution when unscrewing the crimped bolt: This is a risky technique; you may have to upgrade the bolt and cut a new thread. But it did work well for me; I worked the thread back and forth an eighth of a turn at a time.

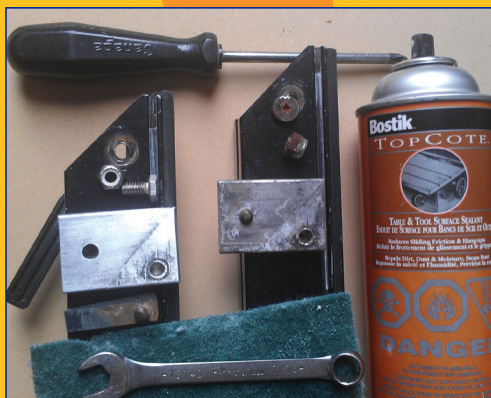
Cleaning Al Sq tubing.

bottom crosspieces. You slide them into the horizontal crosspieces and snap lock them into place. The issue here was severe oxidation of the bare aluminum crosspiece. I had to use too much force to assemble and disassemble the door frame for transportation.

I took the four ends of aluminum square tubing off and discovered that they were held in place with steel bolts and nylon lock nuts. Many of these bolts and nuts were heavily rusted. For less than \$4, I bought new stainless steel bolts and nylon nuts (see photo second from the bottom on p. 48). I'm hoping that this simple replacement may reduce the amount of what I suspect is galvanic reaction taking place between the dissimilar metals in contact with each other. I rubbed the oxide off the aluminum tubing and sprayed it down with Bostik's TopCote product. Assembly and disassembly are now a pleasure. A note of caution: Don't spray the TopCote product in the channel of the frame where the camming blocks will have to bind, as it will cause your camming assembly to slide!

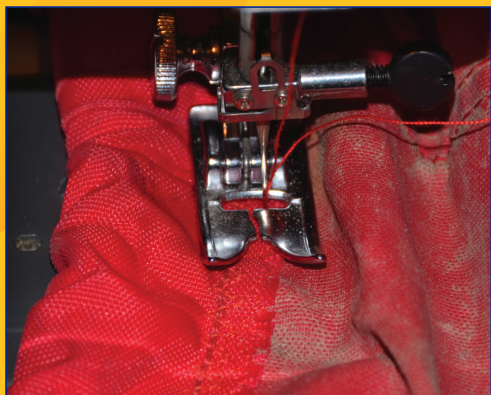
Zig zag sew on nylon.

The red nylon panel of the Model 3 blower door was tattered and torn and needed a face-lift. The bungee cord that kept the panel collar snugly fit around the fan body had broken out of the nylon, making the door panel completely useless. Because the edge of the nylon was badly frayed, there wasn't enough material to sew a proper hemming seam to lock the edge of the fabric into the seam. I pulled out the finest red polyester I had and sewed the bungee cord back in its cloth pocket with a simple running stitch to close up the seam. Once the seam was secured, I switched to a wide zigzag stitch that helped lock the frayed edge of the red nylon collar in place (see bottom photo on p. 48).

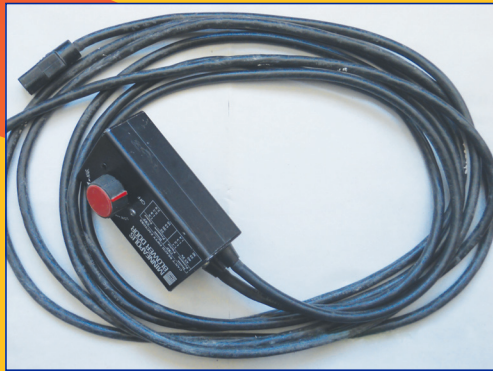
The good.

Take the power cord issue. If you flex a rubber power cord at the same place repeatedly, the flexible rubber will take the strain, but the braided copper conductor will not. (see “The Good, the Bad, and the Ugly” on previous page.) The conductor eventually breaks, one strand at a time. Next thing you know, the control is cutting out the internal break, generating so much heat that it becomes uncomfortably hot to the touch. It should be noted that at 16 AWG (American wire gauge), replacing the

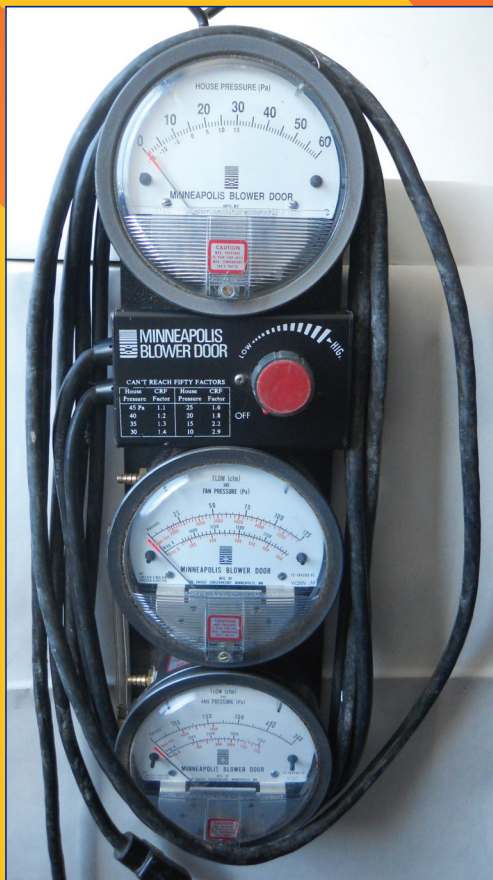
The bad.

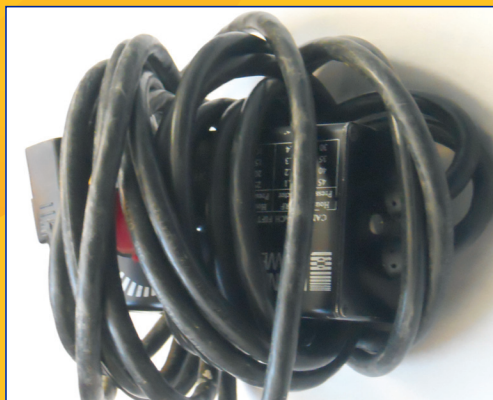
The ugly.

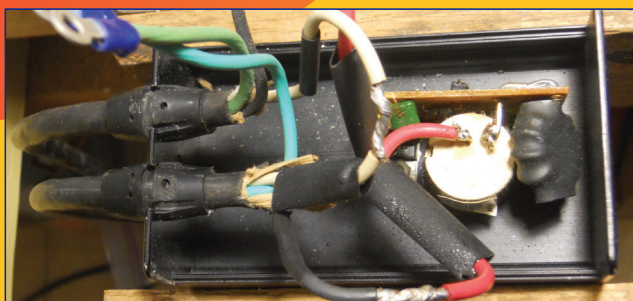
Newer control. with fresh solder connector.

The good news is that this is an easy fix. Change your cord wrapping/storage ways. Cut off 6 inches of cord and solder them to replace the old, crimped connection inside the black box (see photos above). Before you solder you might consider slipping a 3-inch length of snugly fitting rubber hose over the cord as a strain relief adjacent to the black box. It is worthwhile pointing out that the transistor must be bolted and bonded to the hull of the control box with heat sink compound, to help dissipate heat effectively. I am pleased to report that after I soldered that internal connection, there was a significant reduction in the amount of heat generated, and I can now hold the box in my hand comfortably for a test.

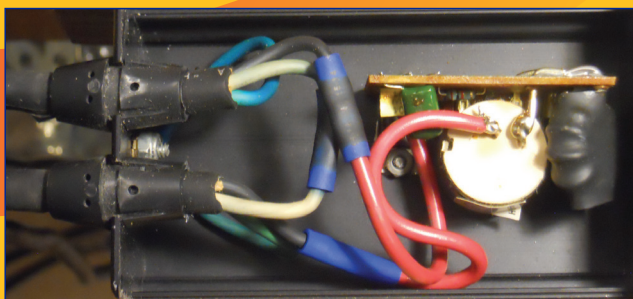
The fan controls for the Minneapolis have come a long way in their design. The problems in the old controls were always the same—cords with broken conductors at the point of entry into the black box and excess heat. This heat was generated either by the transistor, causing the transistor to become unsoldered from the wafer board, or by crimped connections overheating. It's worthwhile to look at these problems in a bit of detail.

Newer control. with overheated solder connector.
